All Saints' Church, Walsoken  
Renovation Project

Title: Church Drain Report

# Drainage Investigation Report

149799.5.BSD

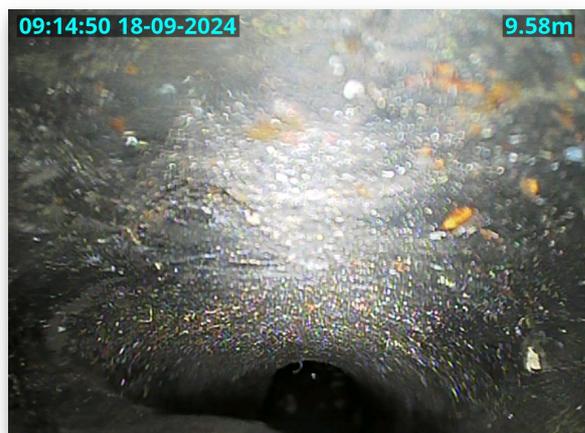
On line 2 we carried out a drain survey downstream from SWMH1 to SWMH2. This revealed a severely blistered and deformed section of pitch fibre pipework at 10m downstream which we were unable to pass through. Our subsequent survey back upstream from SWMH2 revealed further blistering leading to this obstruction point.

Fig 1.1: Obstruction / severe blistering on line 2

Sonde, excavate and replace 1m of 100mm pipework approximately 10m downstream of SWMH1 at a depth no greater than 1.0m through grass.

Re-round and reline 15m of 100mm pipework between SWMH1 and SWMH2.

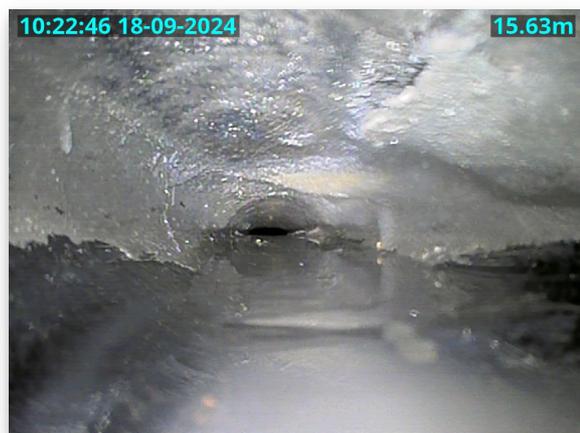
We then completed our next survey of line 8 between SWMH5, situated at the rear right hand side of the Church, downstream from SWMH4 which highlighted further blistering and deformities leading to an obstruction point at 16m downstream.

Fig 1.2: Severe blistering on line 8.

Sonde, excavate and replace 1m of 100mm pipework approximately 16m downstream of SWMH5 at a depth no greater than 1.0m through grass.

Re-round and reline 32m of 100mm pipework between SWMH5 and SWMH4.

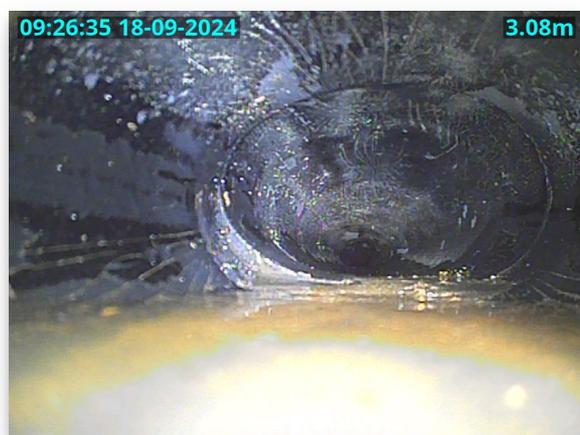
Fig 1.4: Further evidence of deformed pitch fibre pipework.

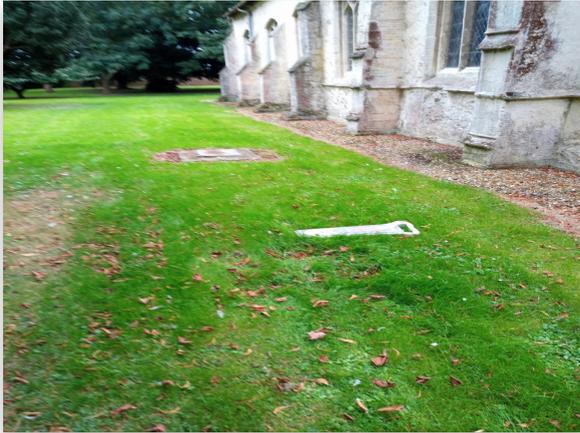
Fig 2.1: Sonde point of obstruction on line 2.

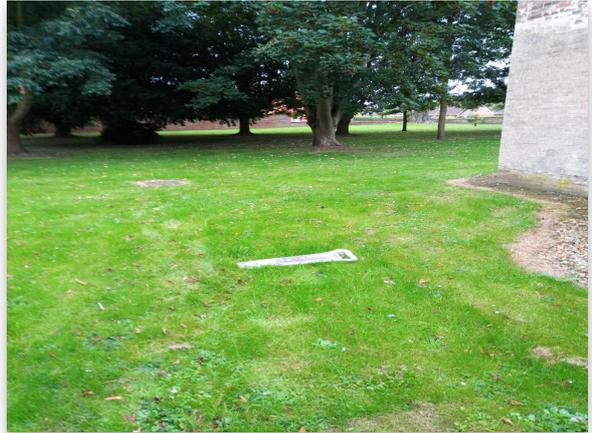
Fig 2.2: Sonde point of obstruction on line 6.

Sonde, excavate and replace 1m of 100mm pipework approximately 2.6m downstream of SWMH3 at a depth no greater than 1.0m through soil.

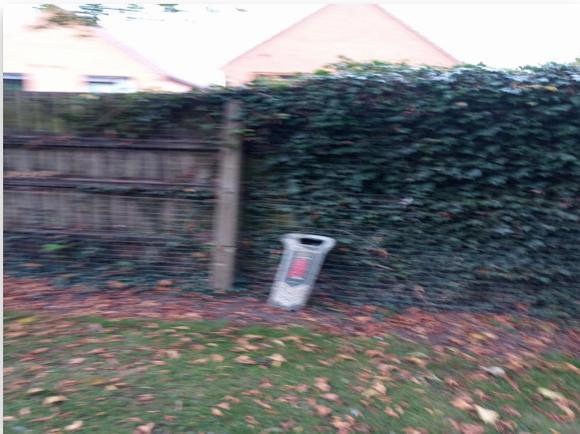
Our CCTV survey of line 7 was performed downstream from SWMH4 and extended off the customers property boundary at 19m downstream. We became obstructed on this run at approximately 24m downstream and were unable to obtain a clear visual on the private pipework within boundary due to the water retention within the drain. We would advise that the Local Water Authority (LWA) are appointed to resolve this issue.

Fig 2.3: Sonde point of property boundary at 19m downstream from SWMH4.

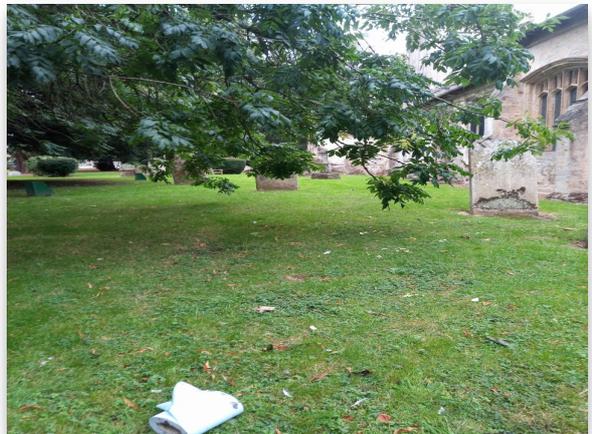
Our CCTV survey of line 10 was done between SWMH5 and SWMH6. This drain runs beneath a plethora of gravestones and is severely blistered and deformed throughout.

Fig 2.4: Plethora of graves at the right hand side of the Church between SWMH6 and SWMH6.

Re-round and reline 24m of 100mm pipework between SWMH5 and SWMH6.
