All Saints' Church, Walsoken
Renovation Project

Title: Quinquennial Inspection Report

THE ELEVENTH QUINQUENNIAL INSPECTION REPORT

Date of Inspection : Tuesday 4th April 2023

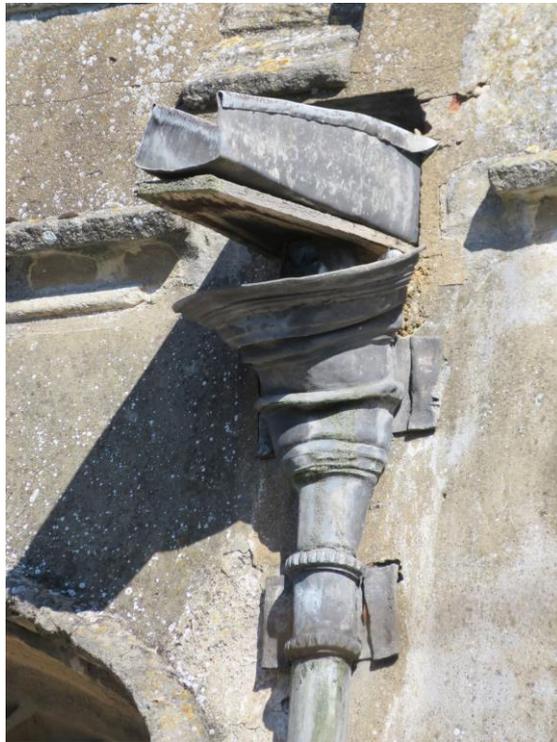
Fig 1.

The cast iron gutter and downpipe to the boiler house are severely corroded, at least two gutter joints leak, the two collars to the downpipes are cracked and the shoe is missing, allowing some of the water to discharge behind the new gully. These rainwater goods need to be overhauled and redecorated as a priority and at least any leaking joints recaulked as these could have an impact on the structural movement.

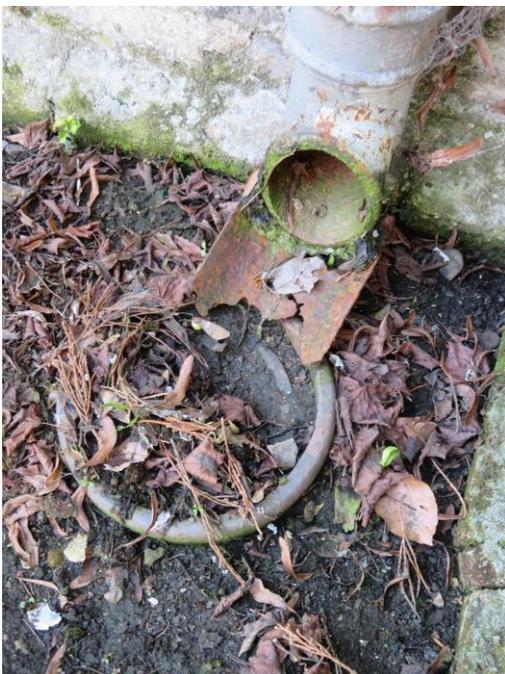
Fig 2.

The drains serving the south aisle are rather inadequate as the downpipes have had to be extended to the gullies and there are no surrounds to contain the water. See drains drawing dated 11th February 2014. The gullies should therefore be improved and the surface water drains to the south rodded and plotted to ensure that they are clear and discharging water away from the building. A new gully has been installed to serve the boiler house downpipe but there is no access to the soakaway. To the north, it has been reported that the gullies regularly overflow and that the system, that is accessible via four manholes, is completely blocked and needs to be thoroughly cleaned out and inspected and any remedial works, such as repairing pipework or installing a new soakaway, carried out. The three north downpipes have also been extended to reach the gullies, but all gullies are blocked, the extension to the central downpipe corroded, *see fig 2*, and the arrangement of collecting water to the westernmost downpipe completely unsatisfactory, *see fig 3*. Improvements should therefore be carried out to the north drainage system as a priority and the surface water drains regularly cleaned out.

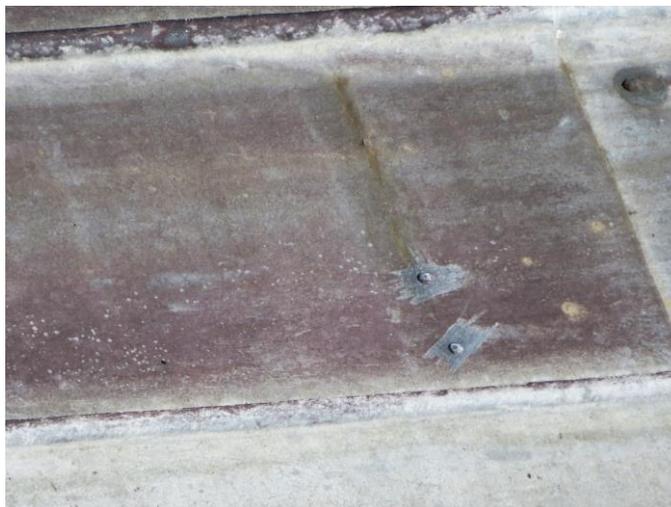
Fig 4.

The leadwork on the roof of the south aisle, to the south of the nave, was only inspected from ground level, and the tower roof, where there is evidence that some of the sheets towards the east end of the roof are slipping, ought to be repaired, and there are open joints to the clerestory flashing chase, particularly under the second window from the west, that need to be repointed, as well as open joints to the west flashing chase that need to be made good. It should also be noted that there is a hole in the lower end of the upper sheet in the second bay from the west, where the roof steps up above the porch, caused by a nail head, that ought to be repaired. *See fig 4.* There are also a number of patch-repairs throughout the roof, and debris on the roof that needs to be removed and the leadwork inspected. At the far east end of the roof, the flashing appears to be satisfactory, and along the eaves, the timberwork is generally in good order.

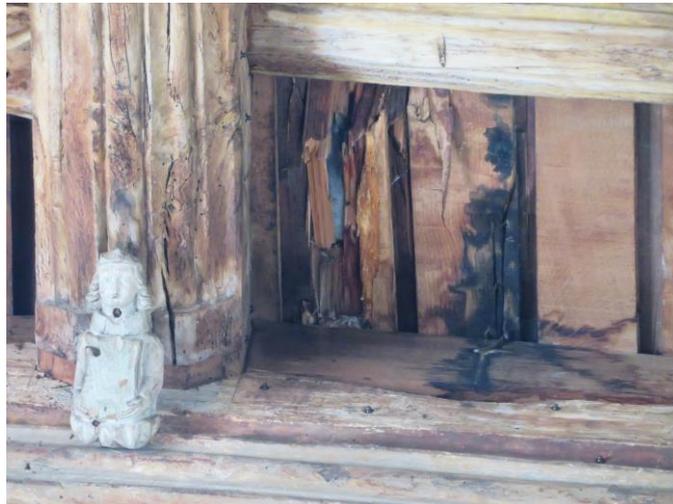
Fig 5.

The underside of the nave roof, including the painted trusses, also appears to be in good condition apart from numerous water stains on the common rafters and boards as a result of defects in the leadwork above. However, it has been reported that there are no current signs of water ingress. It should be noted, however, that immediately to the east of the second tie-beam from the west there is an area of damaged boarding, exposing the underside of the leadwork, *see fig 5*, that ought to be repaired. There are also areas of deteriorating paintwork to the inner rails along the north and south walltops that ought to be redecorated. It should also be noted that there are signs of bore dust below the north rail in the fourth bay from the east that may indicate active deathwatch beetle activity in the roof timbers above.

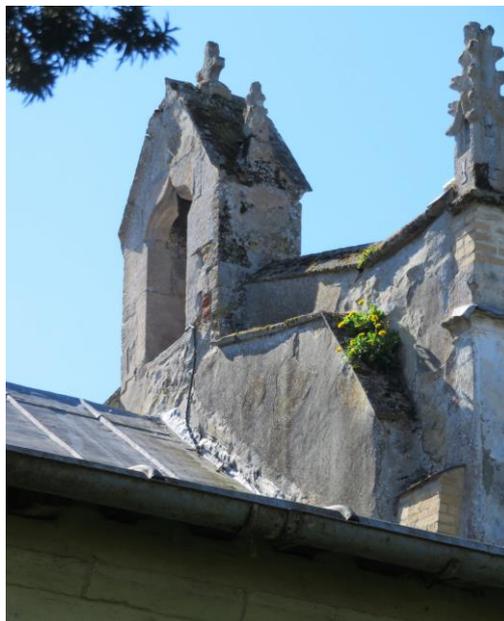
To the east nave gable there are open joints to the stonework and deteriorating render and pointing to the bellcote that ought to be repointed and consolidated, and areas of cracked and damaged render to the gable repaired, to include the removal of vegetation from open joints. Moss on the east coping stones should also be removed and open joints to the copings and to the offset, below the parapet, raked out and repointed. *See fig 13.*
