All Saints' Church, Walsoken
Renovation Project

Title: Quinquennial Inspection Report

THE ELEVENTH QUINQUENNIAL INSPECTION REPORT

Date of Inspection : Tuesday 4th April 2023

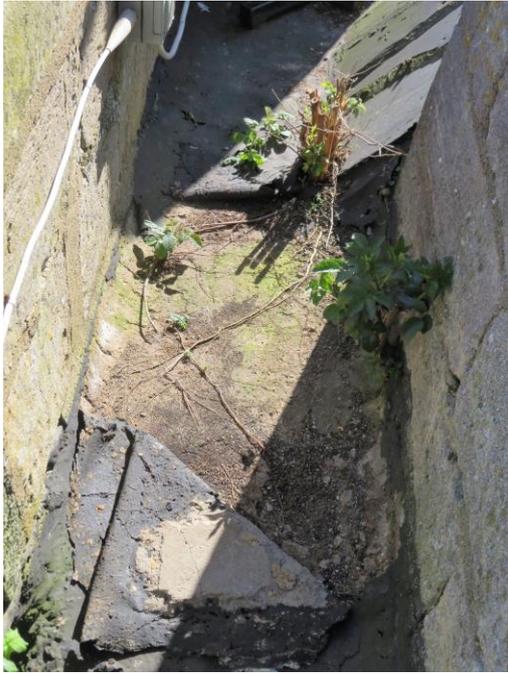
Fig 14.

From the roof of the tower, it is clear there are numerous open joints and areas of cracked and loose pointing to the spire that ought to be pointed, including the hoodmoulds and jambs to the high-level windows in the spire. The timber louvres to the windows, however, are satisfactory. The bituminous finish to the parapet gutter and the corner offsets to the spire is deteriorating throughout and ought to be reapplied to protect the walltops, and vegetation growing from cracks in the parapet gutter removed. *See figs 14 and 15.* This will involve some consolidation to the gutter bottom, where the screeded finish has crazed. *See fig 16.* The parapets and stone pinnacles are in reasonable condition apart from some eroded pointing to the east parapet that ought to be raked out and repointed, as well as open joints to the dressed stonework of the northeast and southeast pinnacles, and the eroded render around the base of the northeast turret, repaired. The corroding iron cramps at the top of the northeast pinnacle might also be replaced in stainless steel, and the detached finial, that stands in the gutter, reinstated to the northwest pinnacle. The timberwork to the access door to the tower roof is weathered and ought to be cleaned and treated and the rusting strap hinges and bolt painted.

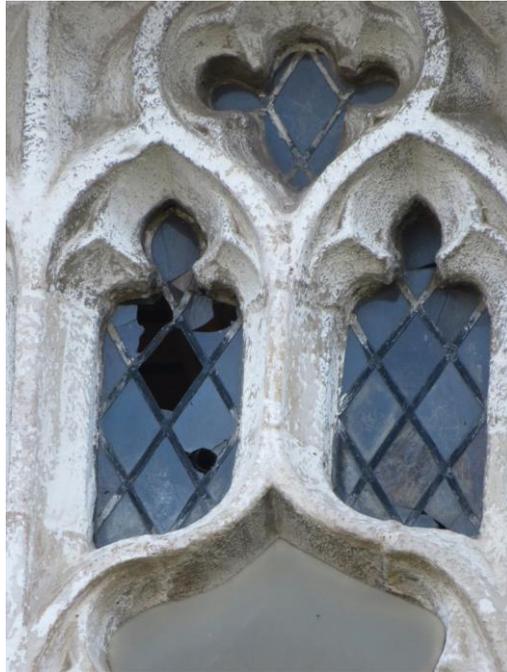
Fig 17.

At the top of the west mullion of the second north nave clerestory window from the east, the nosing is cracked and ought to be repaired. The rusting guards to the third north window in the north aisle, from the west, might also be replaced. A number of tracery lights in the westernmost north nave clerestory window are completely smashed and need to be replaced or the individual tracery lights releaded. *See fig 17.* To the west window in the north aisle, moss should also be removed from the cill stonework.
